PERMITEE-OWNED PROPERTY INVENTORY AND  
GREEN INFRASTRUCTURE RETROFIT PLAN

Marblehead, MA

June 2022

Bobrek Engineering & Construction, LLC

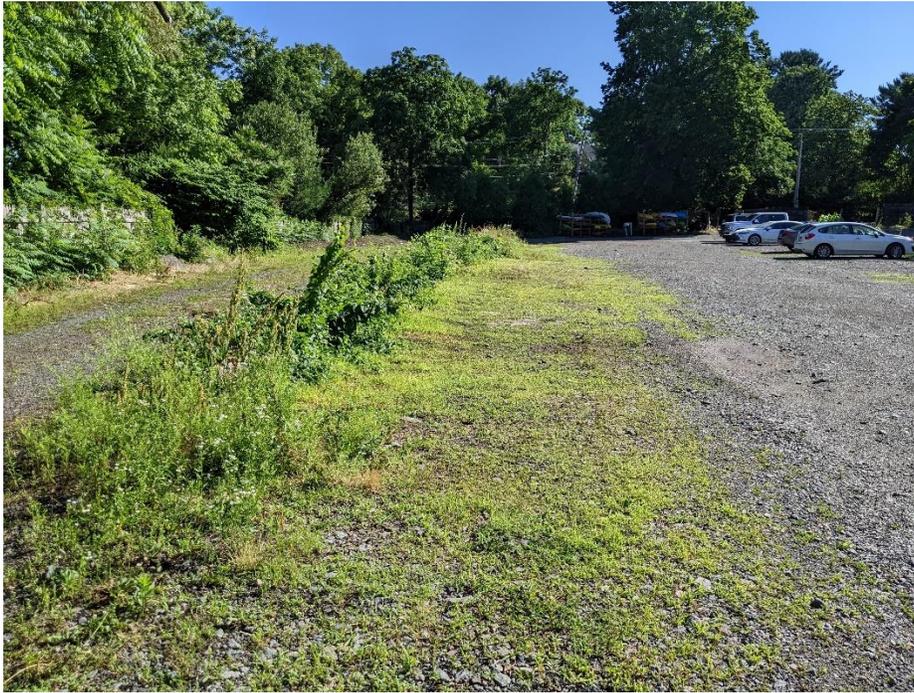
This parking lot is the parking area for the Village Street Public Landing. It is a large gravel parking lot that slopes towards the neighboring property which has experienced flooding in the past as a result. There are three catch basins that are unmapped in the Marblehead GIS system on the site. The catch basins are likely to connect to those in the street that drain to OF29 (Previous ID-1997), which is a high priority outfall with high bacteria counts found in 2021 screenings. There are existing islands of vegetation between parking rows that may currently aid in reducing the rate of stormwater discharge. The Harbormaster also has plans to improve the site soon, therefore additional LID improvements could be implemented simultaneously.

*Parking area slopes towards neighboring property along the fence, causing flooding.*

The flooding on the neighboring property could be prevented with LID techniques. For example, a bioswale that can run down the entire length of the fence would capture the sheet flow of the parking area, filtering the runoff before entering the existing catch basins. The existing vegetated islands, which are acting as grass filter strips, may also be improved with additional bioswales or perhaps even interconnected tree pits that are also connected to the storm drain with an underdrain.

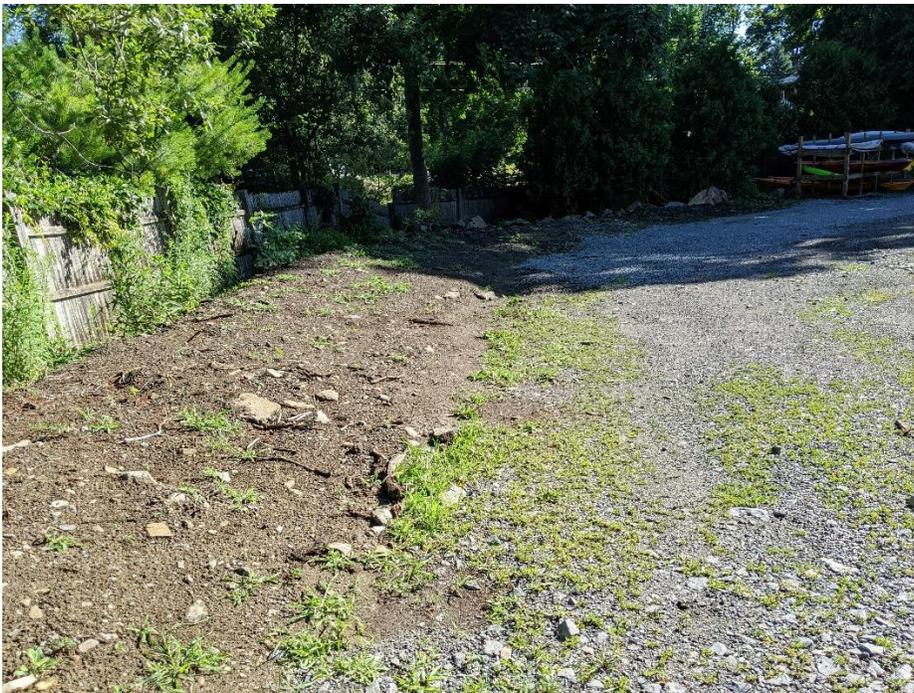
*Along the fence, a structural BMP such as a bioswale may be installed to collect, infiltrate, and guide stormwater to catch basins.*

on the neighboring property and the stormwater that leaves the catch basin on site directly drains to a high priority outfall. A bioswale along the entire length of the fence at the bottom of the slope is recommended at a minimum to address the drainage issues.

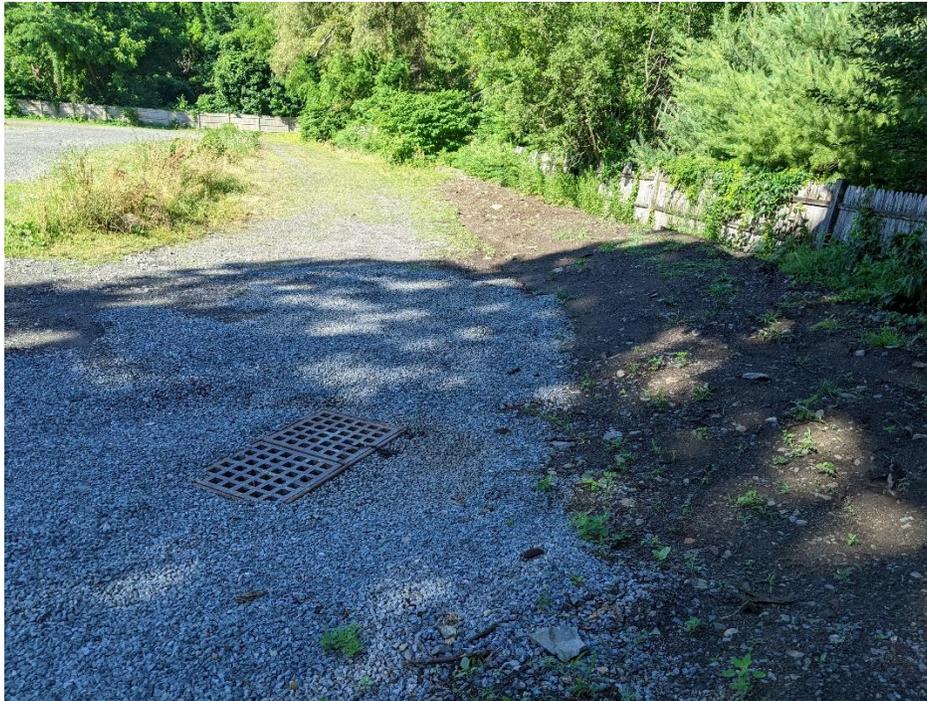
*Existing double catch basin at the bottom of the sloped, gravel parking lot.*

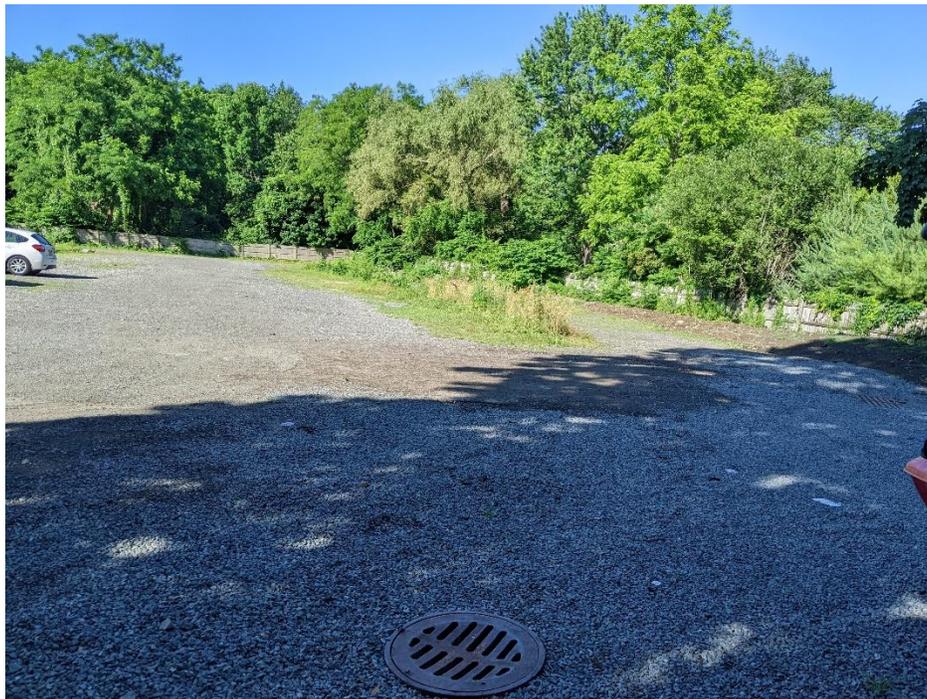
*Another catch basin by the entrance of the parking lot. These drain to a nearby priority outfall.*

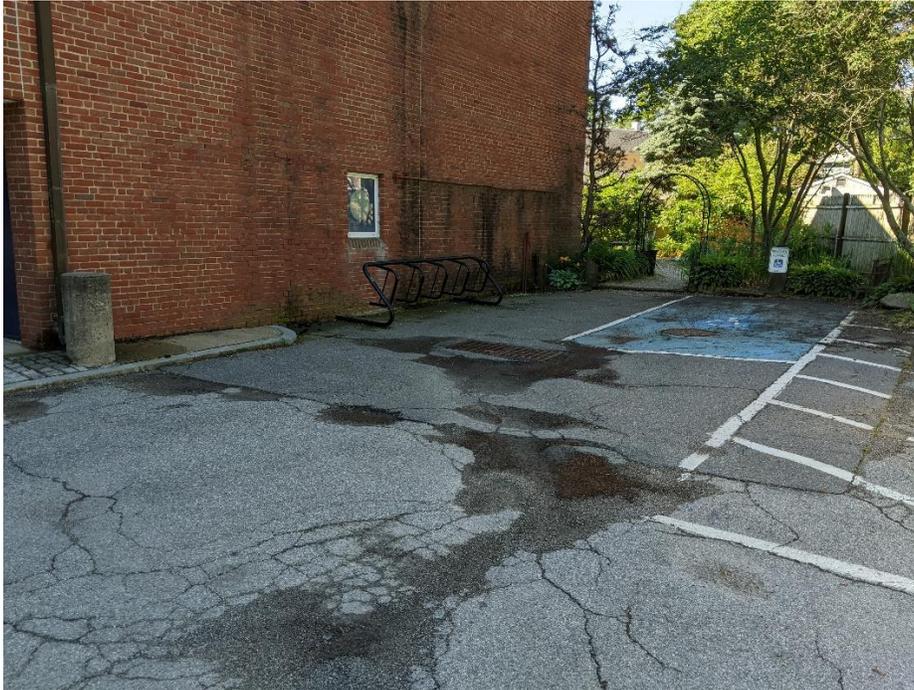
The paved parking area behind the Abbot Library slopes down from the street into a low-lying area. Signs of pooling stormwater are apparent by a double catch basin several feet away from the side of the brick

*Water pools at the catch basins next to the library building. An elevated garden area at the far end of the lot could potentially be utilized for green infrastructure.*

Compact LID techniques were considered for the library parking area since space is limited and it is closely abutting the building and neighboring properties. Planter boxes could be installed along the length of the building to temporarily store and filter the rainwater exiting the gutters that are contributing to the flooding. Permeable paving could be an option for slowing down and absorbing the water depending on the filtration characteristics of the soil on the site and the water table. The existing curb bump out as one enters the parking lot could be modified as a bioswale or tree box filter. The perimeter of the parking area, if space allows, could also be retrofitted with a bio swale to filter and slow the conveyance of water to the storm drain. The catch basins at the bottom of the driveway that collect most of the water could be modified into a rain garden with an overflow catch basin to slow the discharge rate. The rain garden could be an aesthetic addition to the existing garden and be an educational opportunity for visitors. However, the proximity to the building, soil characteristics, and water table must be factored into the final design.

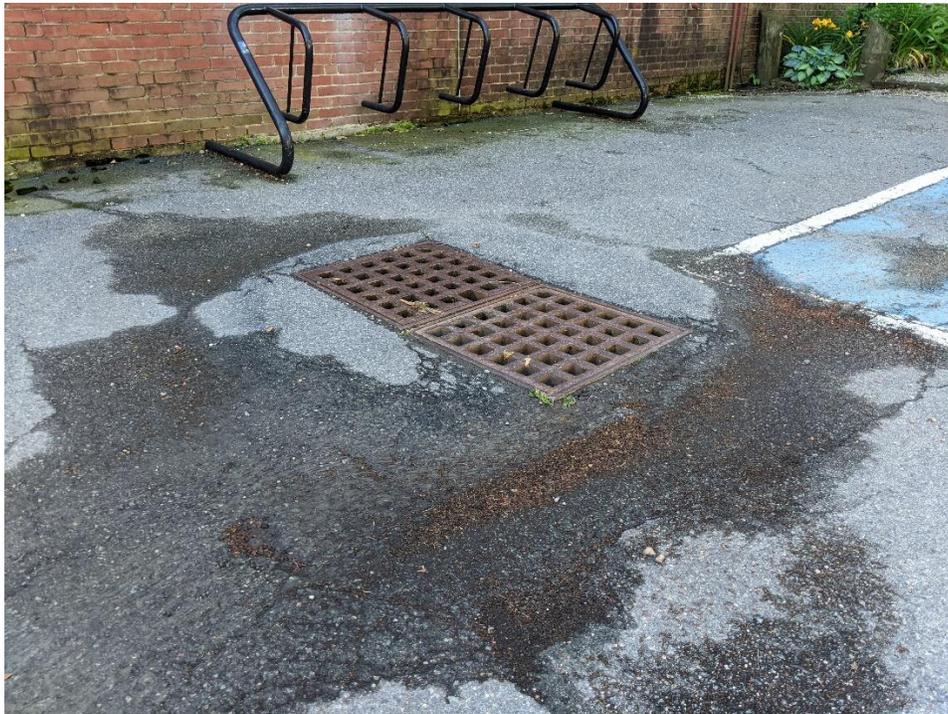
*Complaints of flooding in this parking area make it a high priority for redevelopment.*

Stormwater concentrates at a low point in the parking area behind the Abbot Library, causing flooding during heavy rain events at a catch basin directly next to the building. The parking lot was ranked as high priority due to these drainage issues. The designs for the new parking lot should be modified to implement planter boxes along the building to handle the rain gutter runoff and bioswales along the perimeter and in the curb bump out to slow the rate and volume of stormwater discharge. The catch basin receiving most of the sheet flow may also need to be replaced with a rain garden with an overflow catch basin to slow the discharge rate while preventing flooding.

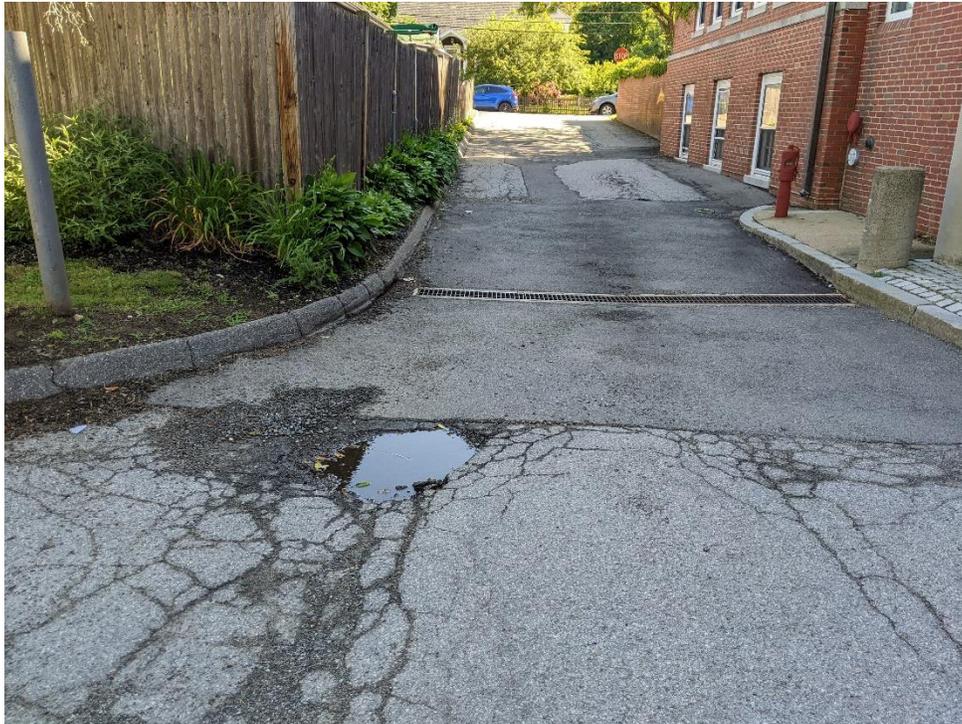
*A long catch basin on the steep sloped driveway collects some runoff from the street. On the left, a vegetated island could be utilized for green infrastructure.*

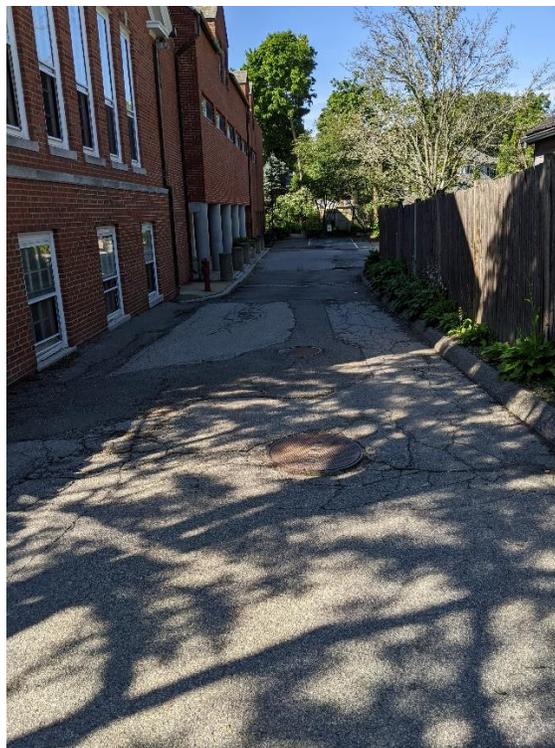
*The building's gutter system discharges to the parking lot. Planter boxes could be placed along the edge of the building to collect and slow the discharge of roof runoff.*

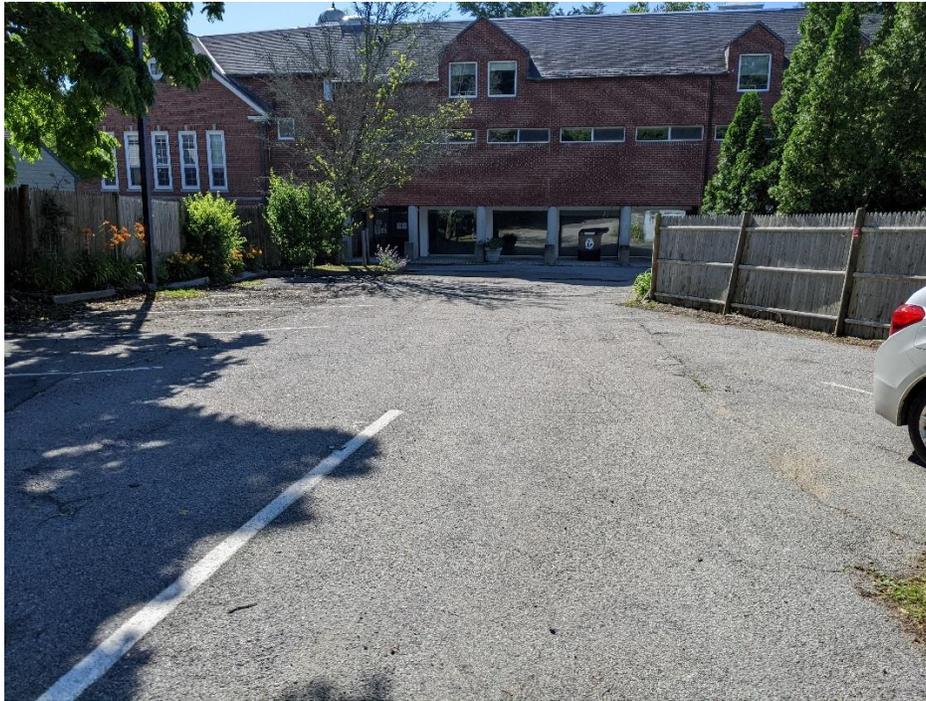
*Neighboring properties are close to the edge of the parking area, and the slope of the parking areas goes towards the library building.*

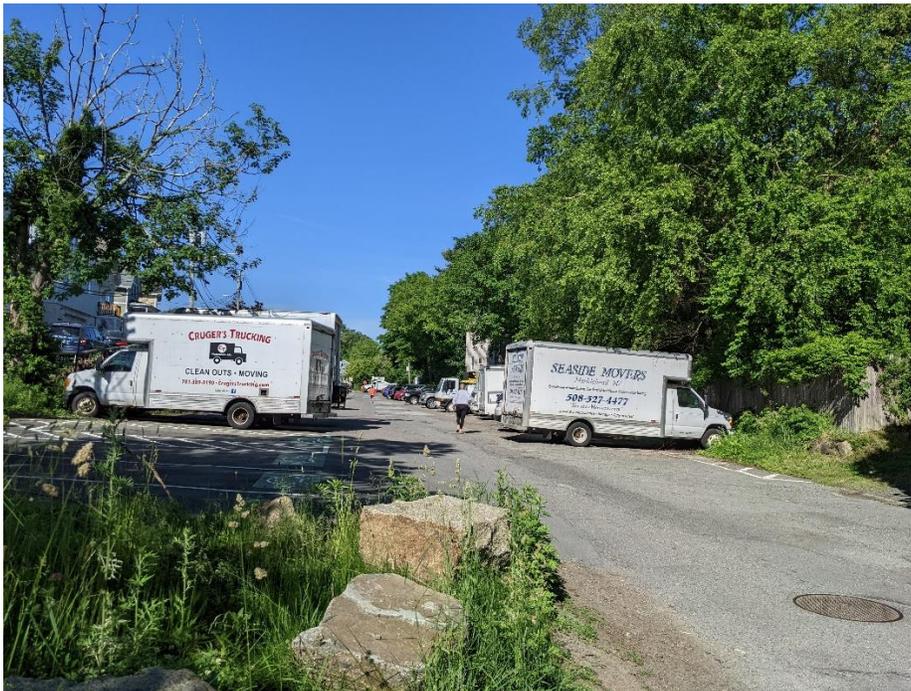
*There are no catch basins or stormwater controls on this site. A vegetated island at the bottom of the parking lot could be utilized for green infrastructure.*

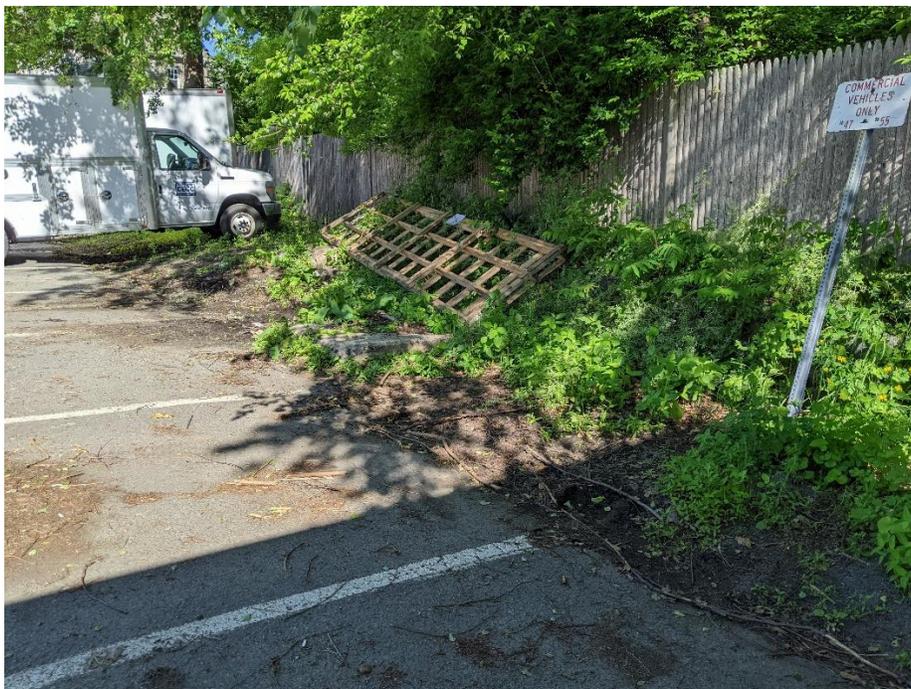
*There is existing green space along the edge of the parking area that could be used for a bioswale.*

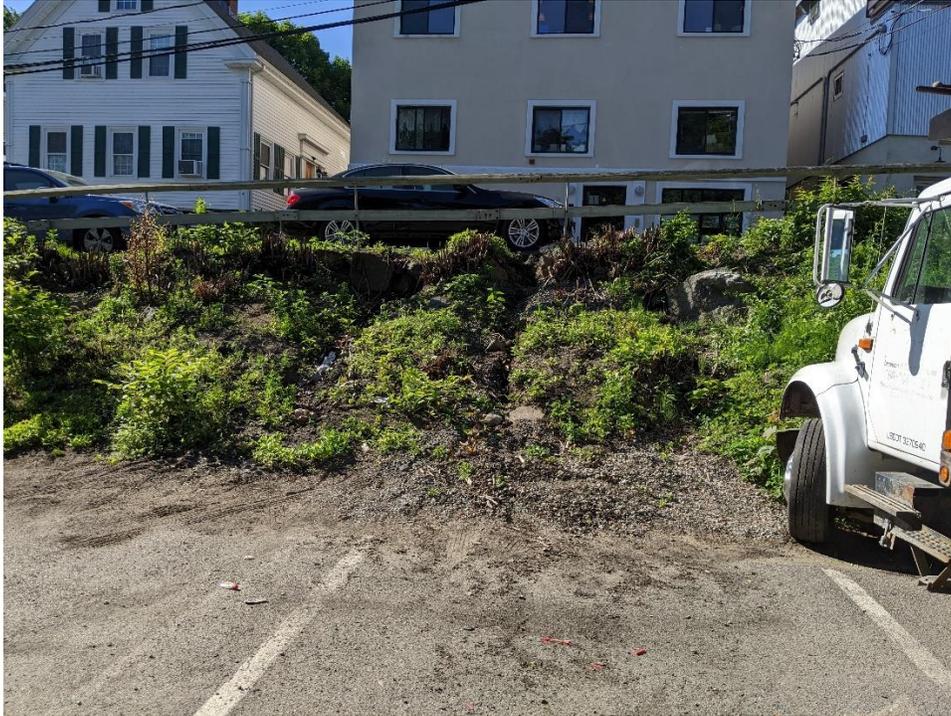
The parking area on Roundhouse Rd is a long, narrow, paved lot with two steep slopes of rock and vegetation coming down from the street and neighboring properties. These slopes have visible erosion, seen notably on the slope coming down from Anderson St. The parking lot is slightly sloped going down towards School Street with no catch basins despite the storm drain running down the length of the area. There are several drain manholes in the middle of the parking area. The lot is located within the Riverhead catchment area, which is ranked as high priority for improving the quality of stormwater. While there are no plans to make improvements on the site, there is a strong interest in this site for adding green stormwater infrastructure.

*The steep slope along one edge is eroding.*

Each side of the parking area currently acts as a vegetative buffer since it includes dense vegetation and trees. However, the steep slope must be additionally stabilized, or the stormwater diverted on Anderson Street to prevent erosion of this slope. Along the length of the sides of the parking lot could also have bio swales or tree pits. Vegetated islands with bio swales going perpendicular to the slope of the pavement could also slow the flow of water going down the length of the parking area. The drain manholes in the middle of the parking lot could also be retrofitted with hydrodynamic separators to help collect sediment, oil, and grease. The grassy area at the bottom of the slope that contains the granite blocks could be modified into a rain garden with an overflow catch basin. The addition of green infrastructure in this area could drastically improve the aesthetics and stormwater management of Roundhouse Road.

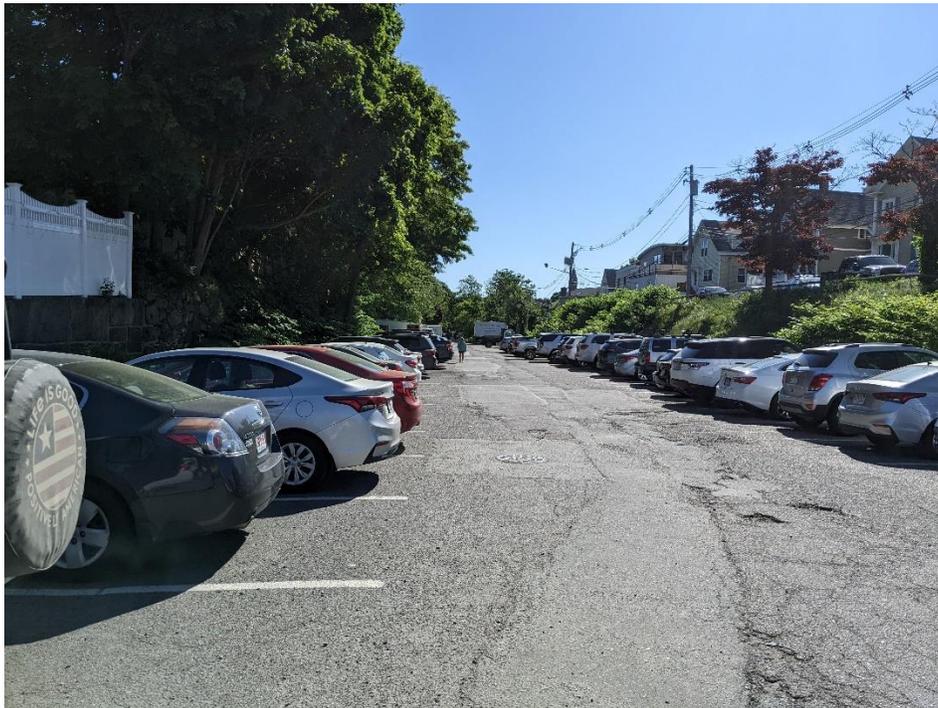
*A drainpipe runs through the length of the parking lot, allowing for the opportunity to add stormwater infrastructure.*

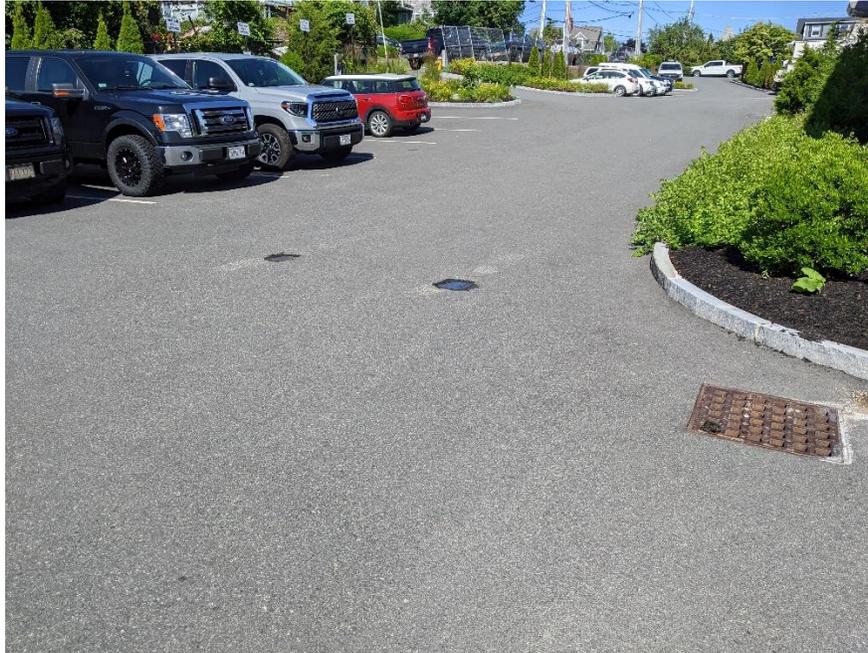
*The parking area slopes down towards the harbor, with two catch basins on the paved section of the lot.*

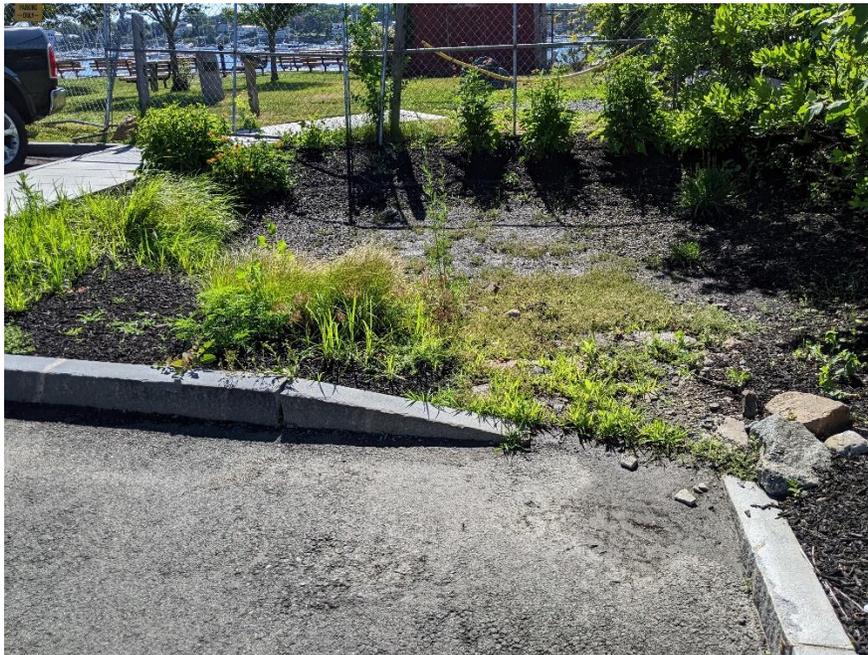
The municipal light plant parking area has had recent updates with the addition of granite curbing, vegetated islands, and two bioretention sites at the bottom of the slope on either side of the parking lot. One of the retention areas without a catch basin does not appear to be effective due to signs of pooling and erosion on the adjacent pavement. The second retention area with a catch basin could also be improved due to observed staining from pooling on the pavement that seems to overflow to a second catch basin beside the building. This catch basin is downslope from the building's rain gutter, which is causing mulch to be eroded and discharged down the drain. All the catch basins on this site drain immediately to a high priority ranked outfall on the other side of a retaining wall. There are currently no design plans for this site, but the town is interested in resolving the drainage issues.

*One of two bioretention areas that appears to not infiltrate due to signs of sediment setting on the pavement.*

The two retention areas at the bottom of the sloping parking lot should be redesigned to better collect and contain stormwater. The depths of the beds are very shallow and may be dug deeper if it is appropriate for the site. The retention areas should also be planted with more dense vegetation to aid in absorbing and filtering the stormwater. The garden beds and curbed islands could be modified into bio swales with curb cuts or planter boxes that prevent washout of the mulch and soil. The catch basin at the

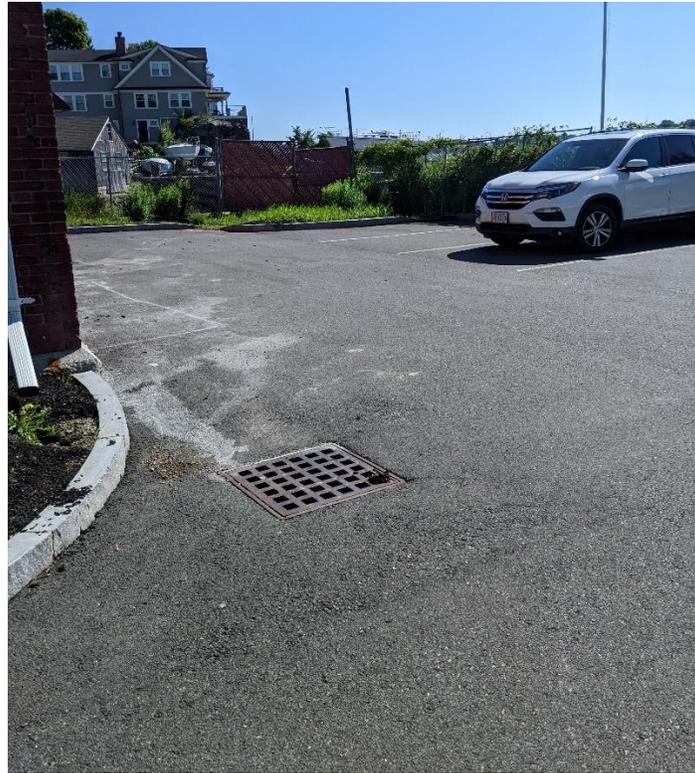
*The building's gutter system discharges to the parking lot, causing erosion of the mulch in the garden bed. The bioretention area at the far end also seems to drain to the catch basin, causing discoloration of the pavement.*

bottom of the parking lot on the corner of the building could also be retrofitted with a filtration insert, since there are signs of sediment on the pavement left by stormwater entering this catch basin.

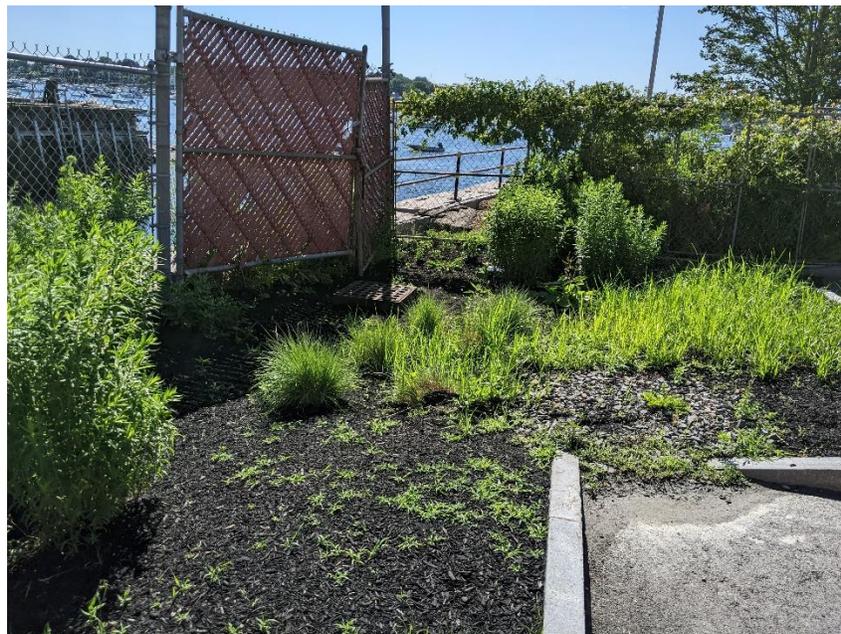
*The second bioretention area does not seem to collect and infiltrate runoff effectively. An overflow catch basin also exists in this area.*

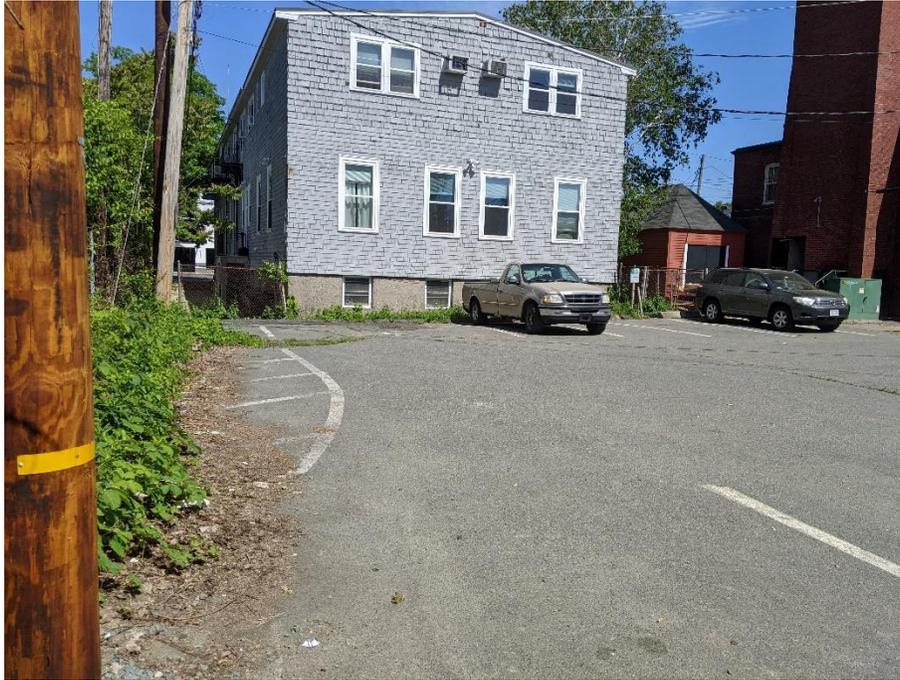
The parking lot behind the restaurant School Street is a small, paved area that seems to partially drain towards a catch basin next to a building on the neighboring property. There is also a second long catch basin at the top of the driveway next to the street. These catch basins and drainpipe need to be investigated and mapped more accurately. There does not seem to be erosion, but the vegetation around the perimeter of the site seems to be overgrown and not maintained. While there is no schedule work for this parking lot, there is construction planned at the Shrine of St. Nicholas, the neighboring property. It could be beneficial to also improve this site around the same time as this other planned work.

*There is one catch basin in this parking area next to a neighboring building. There is another long catch in the driveway next to the main street.*

The parking lot behind School Street may be a good candidate for permeable paving, because it is small and low traffic. A bioswale or tree pit system could be constructed around the perimeter that leads to one of the catch basins on the site.

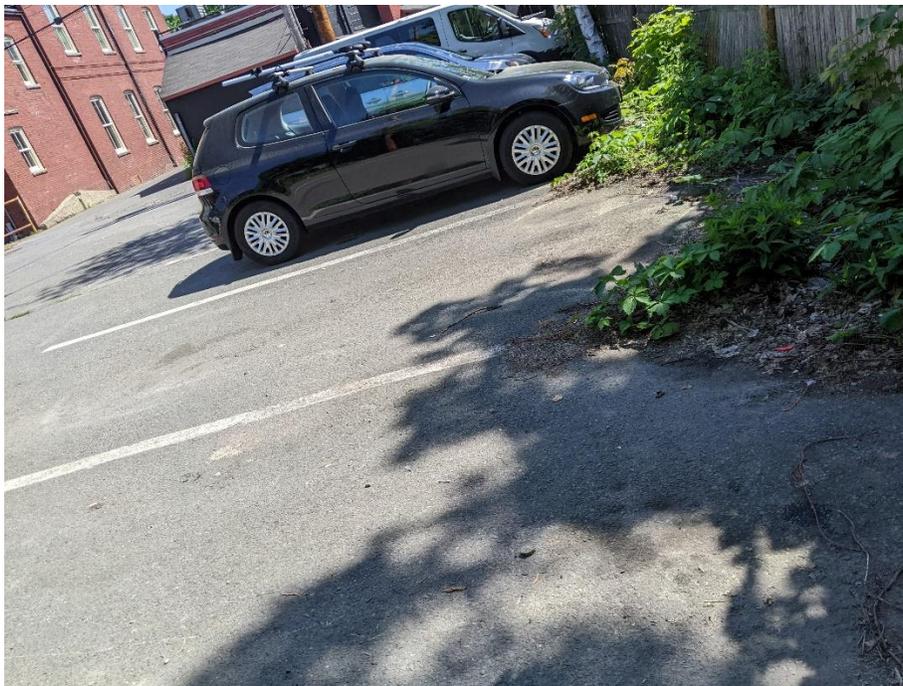
*The parking area is small with some green space along the perimeter.*
